THE SANDS

TORQUAY 3228 VICTORIA

Street Tree Assessment 2018

In reference to: Health Assessment of Trees on Residential Naturestrips

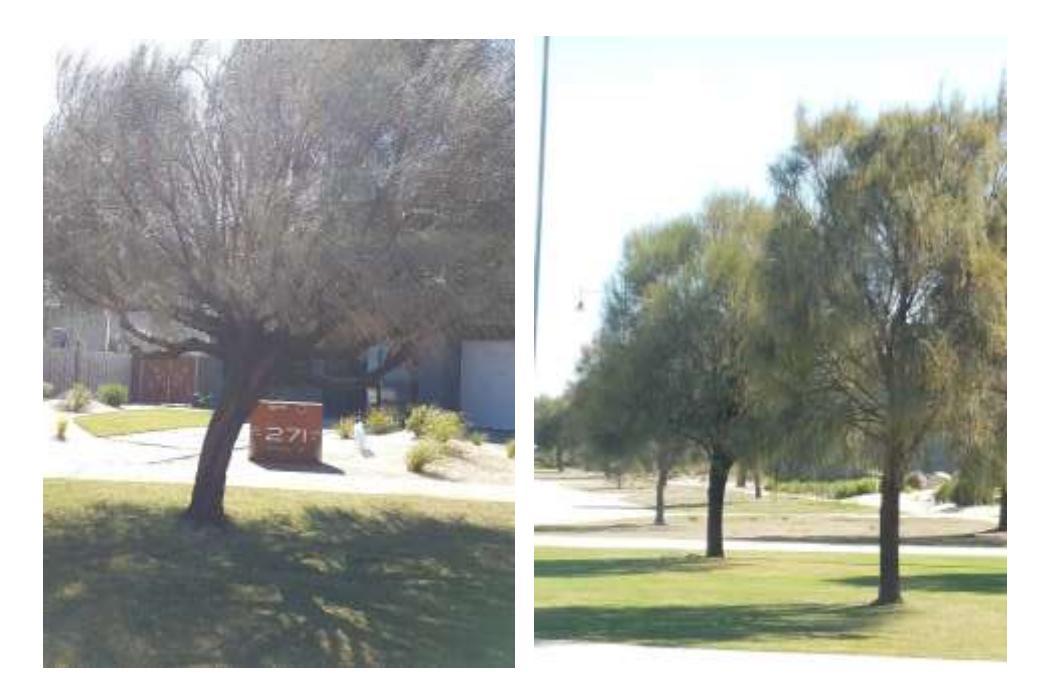
Poor Tree selection (left) will never produce sound trees (right)

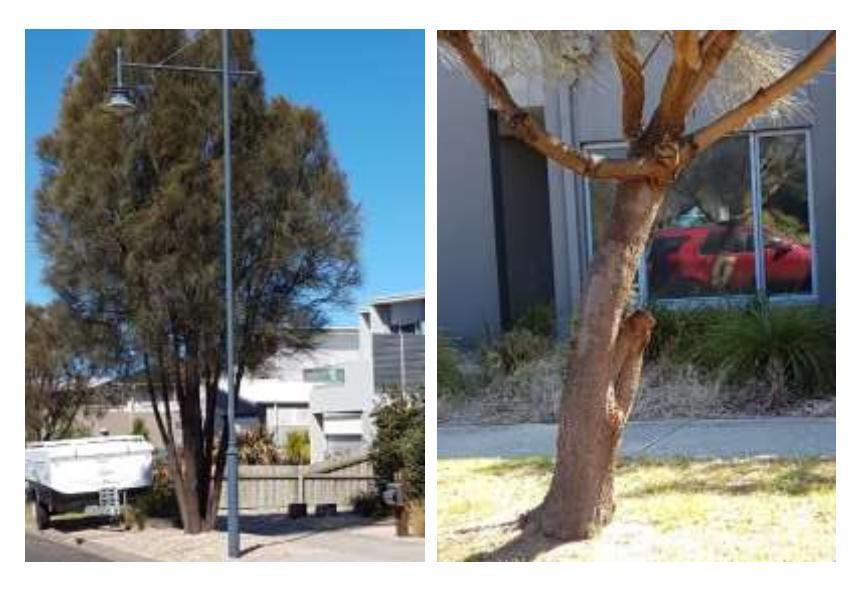
Poorly pruned and managed young stock planting results in poor quality high failure risk tree assets.

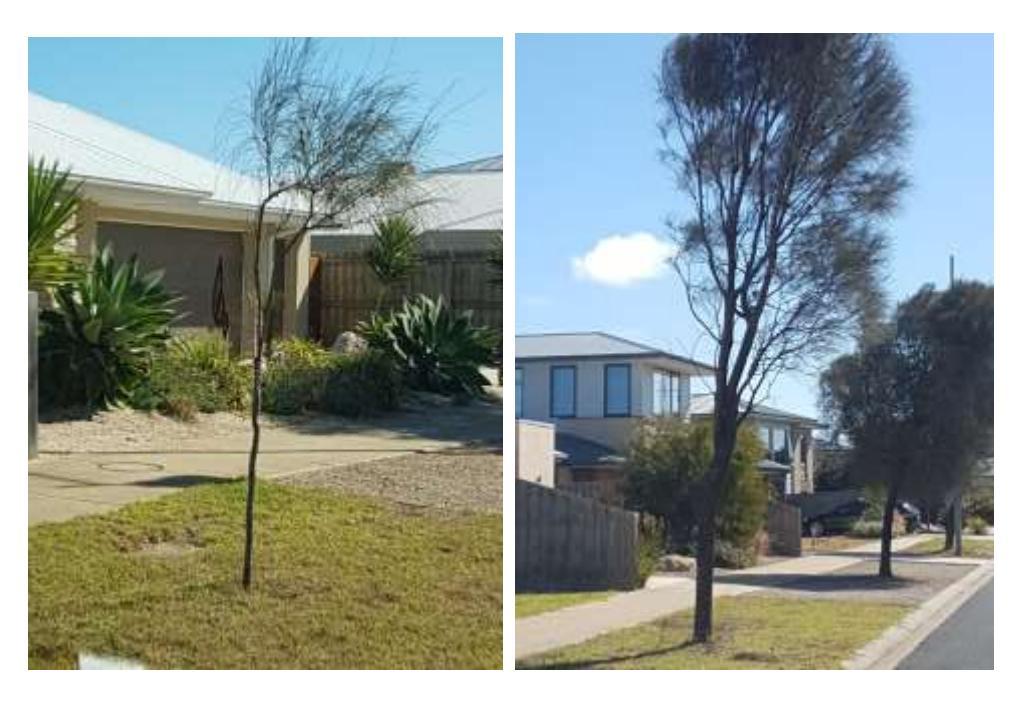
Good stock selection and pruning avoids bad stem to canopy ratio and failing of trees latter in time

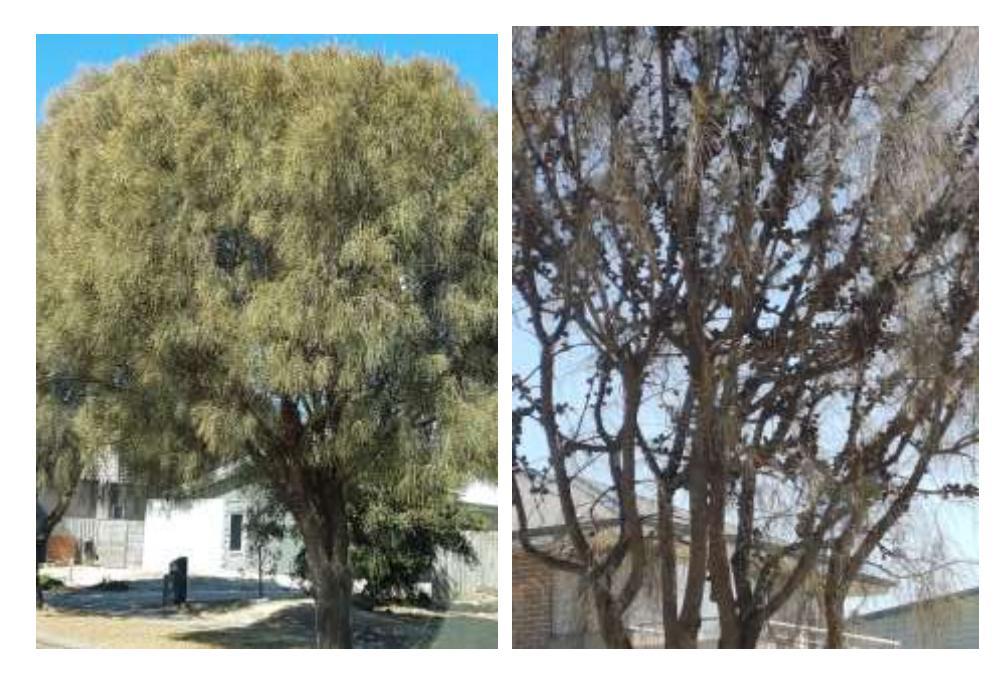
'Male' trees and 'female' trees. Avoiding species with bad traits can solve many issues related to street trees.

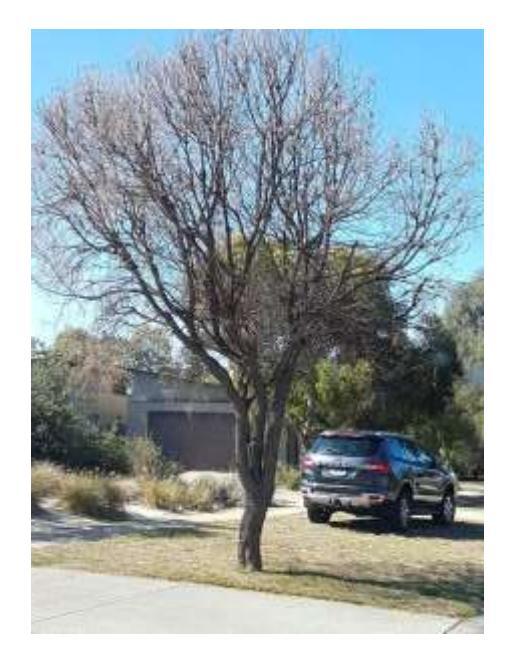
Trees not managed for a single trunk or poorly pruned when young often develop major vascular issues, cannot with stand dry soils and often fail or die when they should be in their growing prime.

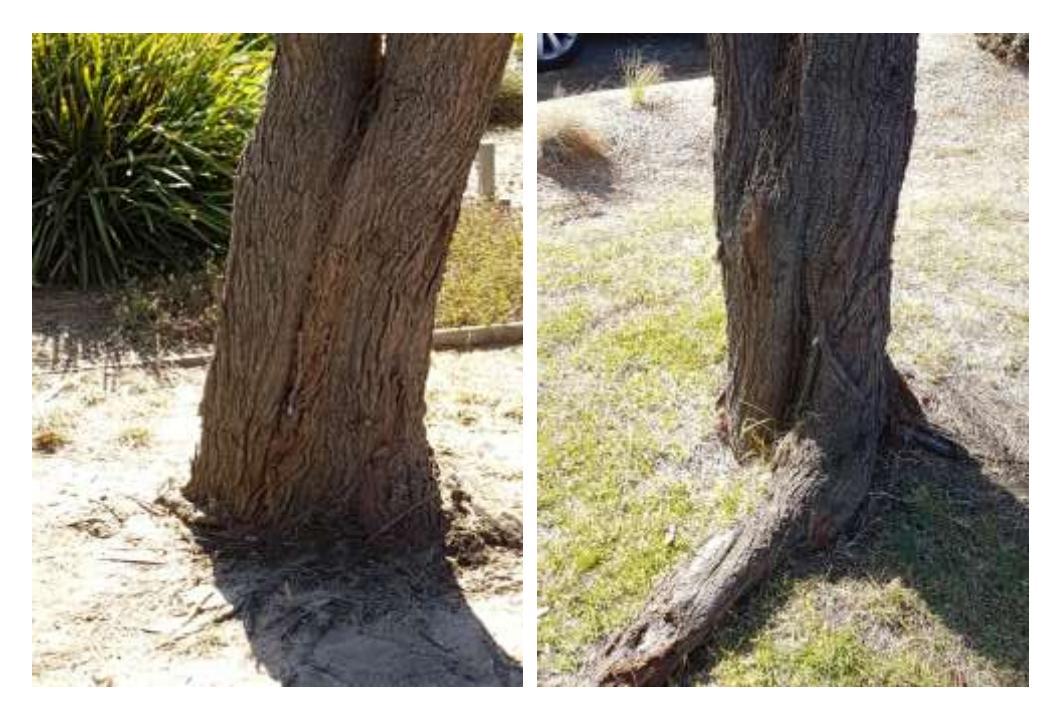
Bifurcated trunks on trees often fail and remain upright as dangerous trees before failing expectantly. Exposed roots are resultant of low quality stock or poor planting hole preparation. Stock selection and correct planting is very important when trees are required to perform for a long useful life.

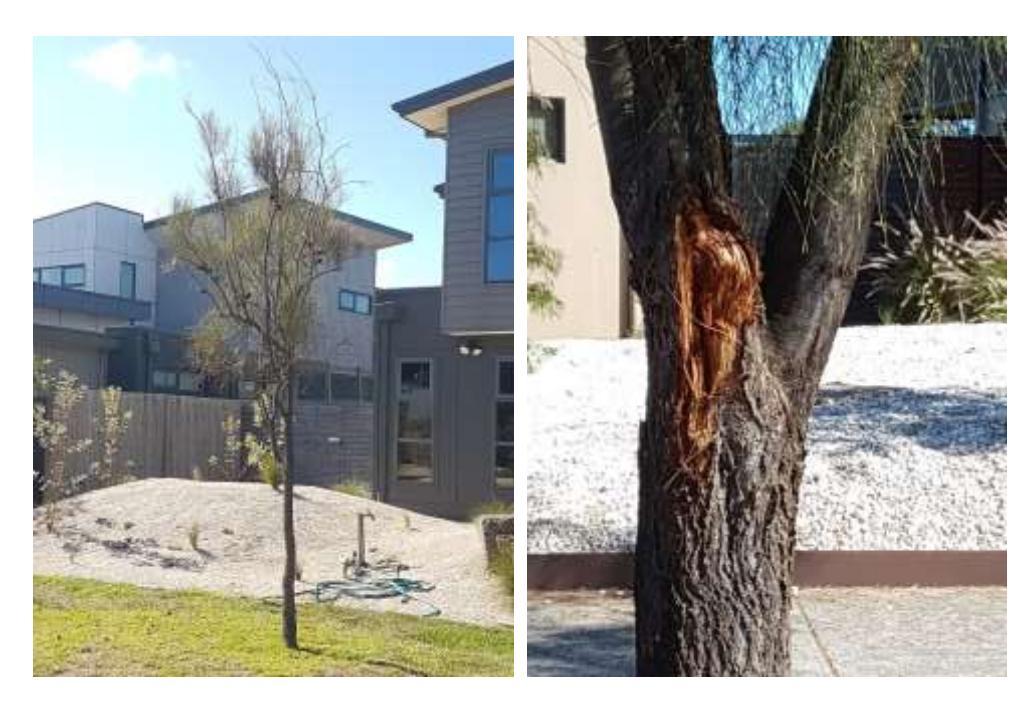
Trees with deadwood in the upper or lower canopy at a young age have major root issues. Once in a state of advanced decline such as this tree (left) Retention is fruitless and tree loss inevitable, it's often best to cut your losses and start over. The same is the case when major structural limbs are lost and failure wounds enter deep into vascular and structural tissues (right).

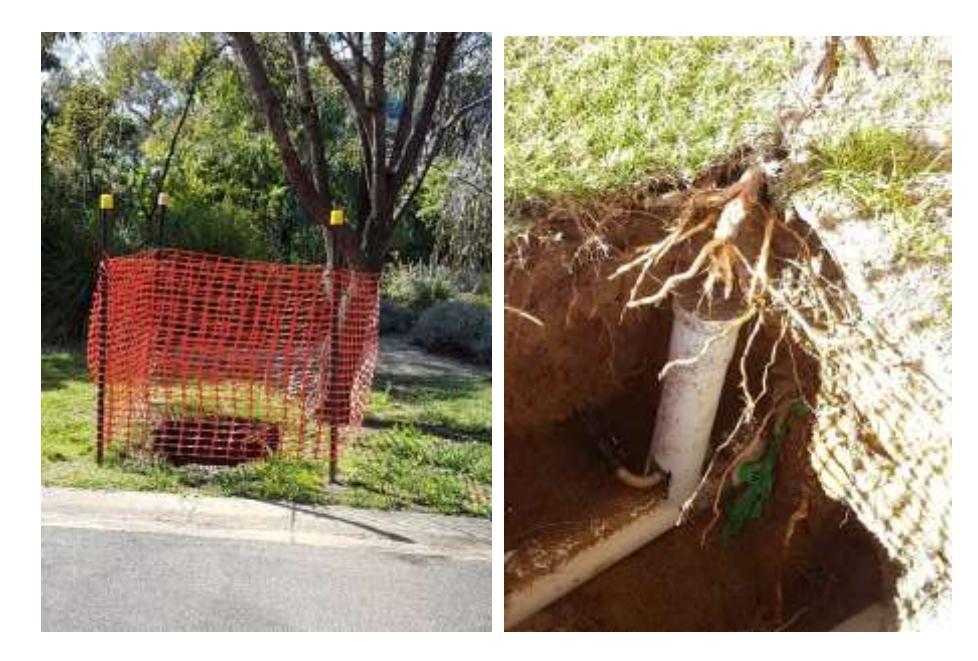
Major impacts in to a tree root zone and not following best practice as out lined in AS4970-2009 Protection of trees on development sites often results in very serious tree impacts. Retention of such trees often sees trees die over time or fail because of the seriousness of burring structurally deficient impacted tree root plates. This tree should be removed, the issue sorted and a replacement tree replanted.

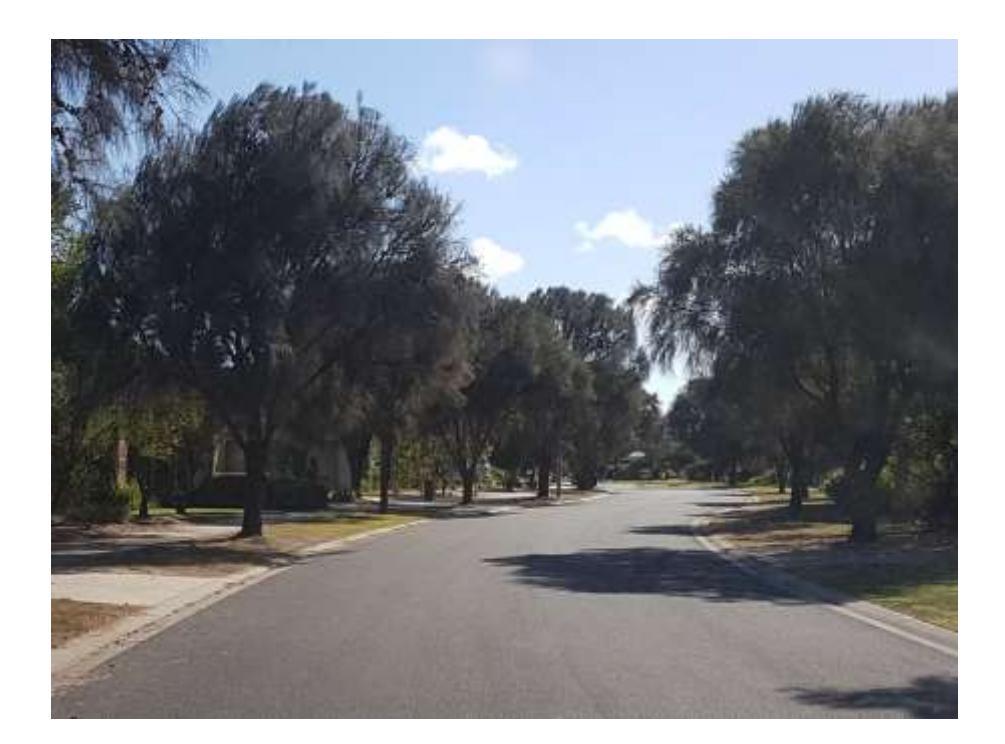
Sound selection of stock and sound early maintenance results in an evenly grown and canopied street. (above)

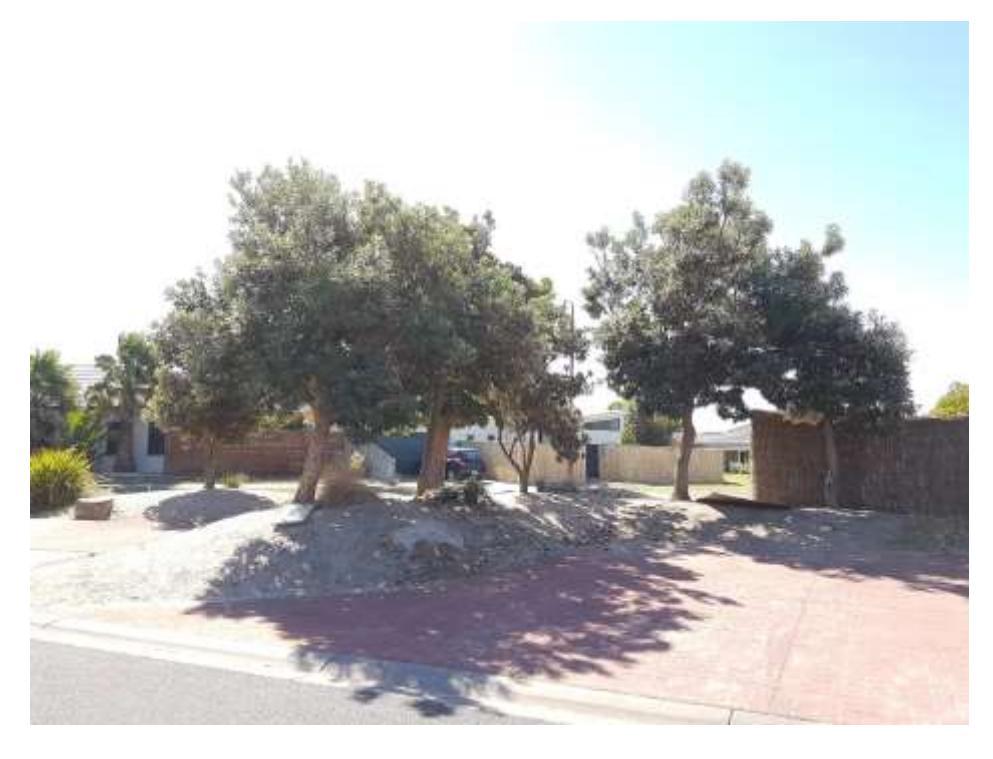
Alternative species selection avoids mono-culturing and all the issues associated with such a proactive. Alternative species also offer sounder assets with longer useful lives. (below)
